**PARTIAL
STURAA TEST
7 YEAR
200,000 MILE BUS
from
ELDORADO NATIONAL, INC.
MODEL 240 AEROTECH
OCTOBER 2000
PTI-BT-R2014-13-00-P**

Eldorado National submitted a model 240 Aerotech, diesel powered 17 seat bus, for a Partial STURAA Test in the 7yr/200,000 mile category. The Federal Transit Administration determined that the following tests would be performed: 1.2 Servicing, Preventive Maintenance, Repair & Maintenance, 2. Reliability and 5.7 Structural Durability Test. The odometer reading at the time of delivery was 1,196 miles. Testing started on August 1, 2000 and was completed on October 6, 2000. The Check-In section of the report provides a description of the bus and specifies its major components.

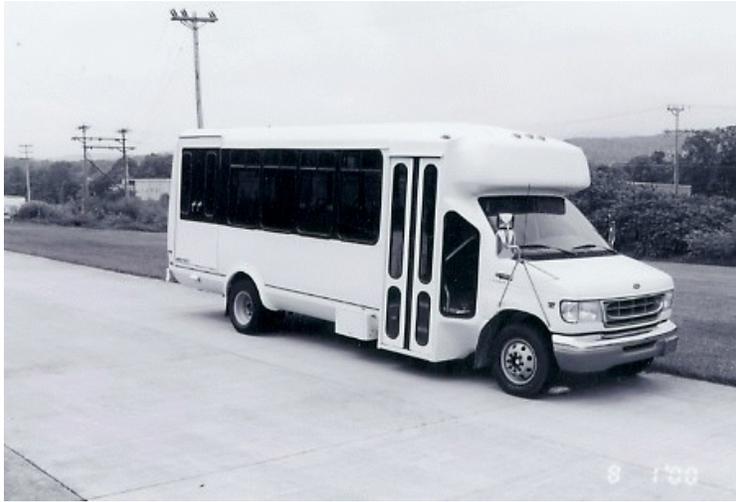
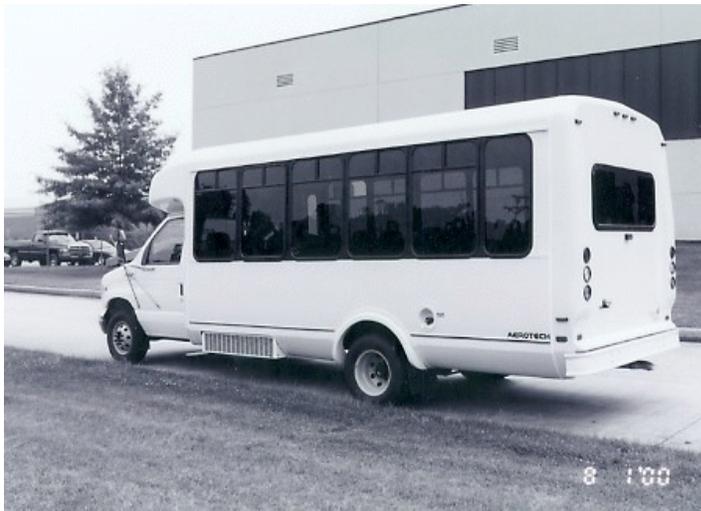
ELDORADO NATIONAL'S MODEL 240 AEROTECH

The test bus is manufactured using a Ford E-350 Super Duty Chassis. The bus has a front door, located to the rear of the front axle, and a dedicated wheelchair access door equipped with a Ricon Corp. model S2005-510 wheelchair lift to the rear of the rear axle. The engine type is a diesel fueled Ford Power Stroke 7.3 L. The transmission is a Ford 4R100E.

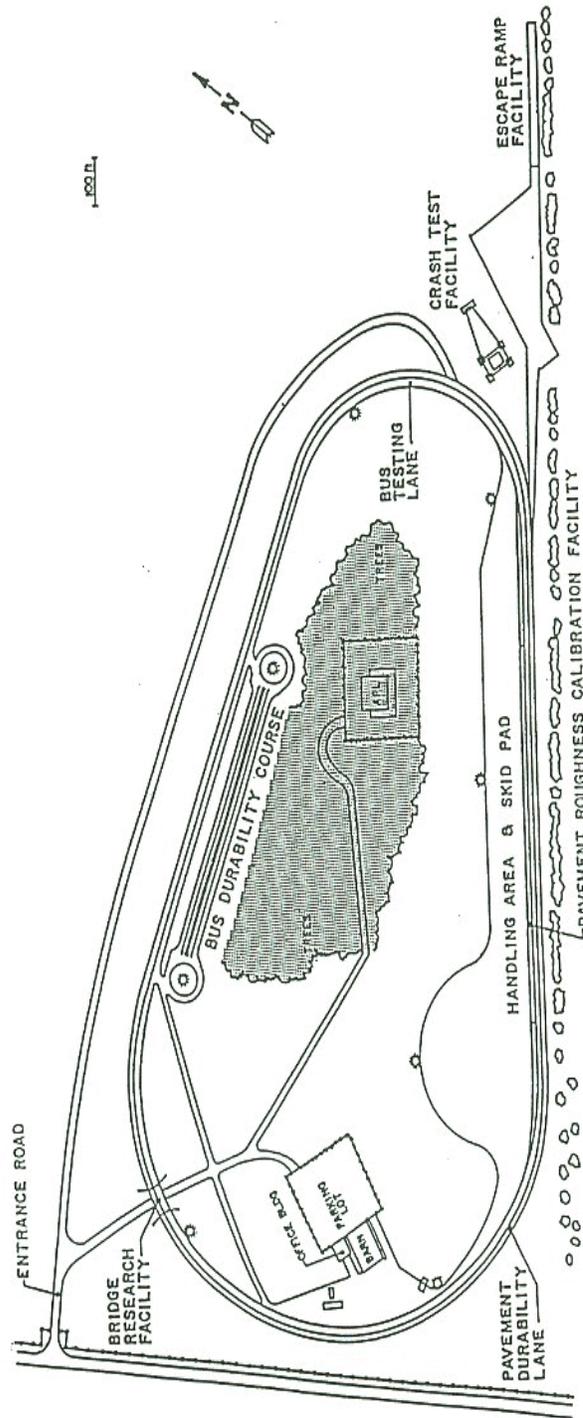
“PLAN VIEW OF PENN STATE BUS TESTING AND RESEARCH FACILITY”

The following mileage summary presents the accumulation of miles during the Structural Durability Test. The driving schedule is included, showing the operating duty cycle. A detailed plan view of the PSBRTF and Durability Test Track are attached for reference. Also, a durability element profile detail shows all the measurement of the different conditions. There were no failures encountered during the Structural Durability Test.
