PARTIAL
STURAA TEST
7 YEAR
200,000 MILE BUS
from
SUPREME CORPORATION
MODEL SENATOR S II

MARCH 2005

PTI-BT-R0502

The Pennsylvania Transportation Institute

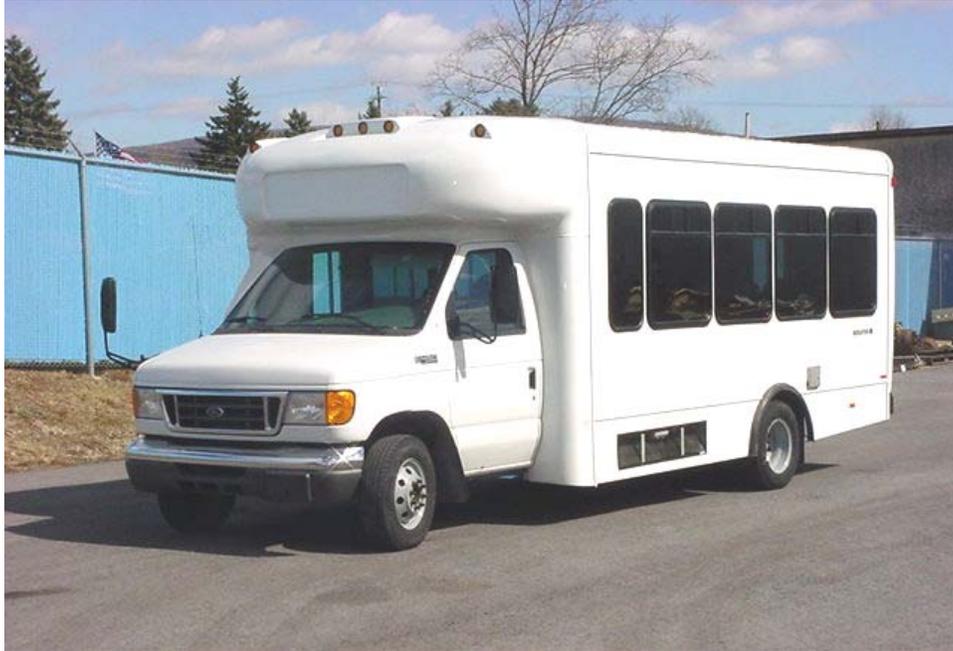
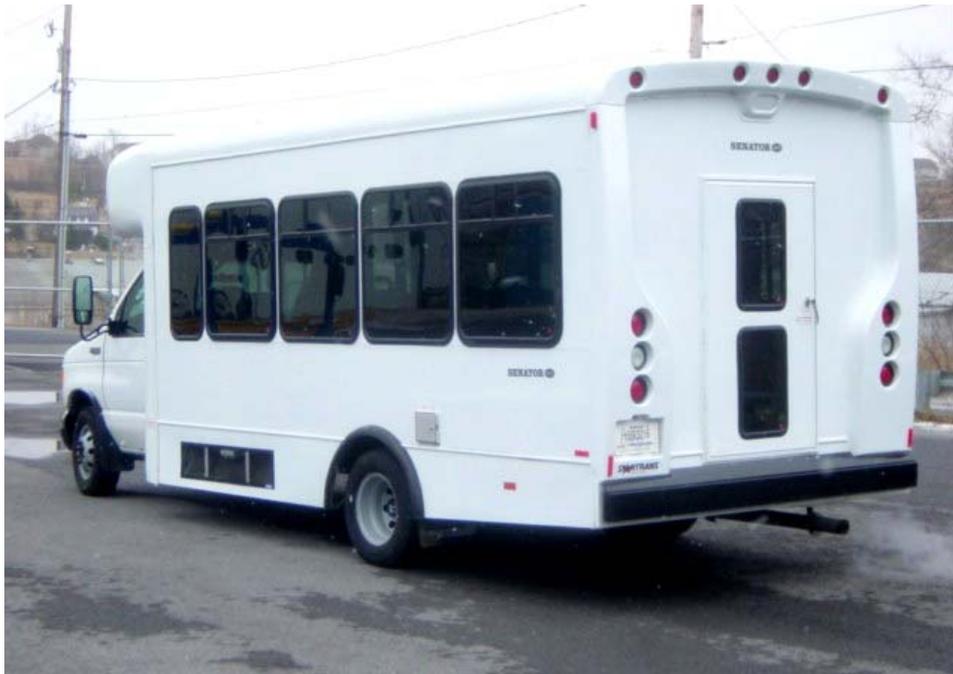
SUPREME CORPORATION'S MODEL SENATOR SII

The test bus consists of a Supreme Corporation, model Senator SII. The test bus is built on a Ford E-450 Super Duty chassis. The bus has an OEM driver's and passenger door rear of the front axle and a passenger door just aft of the cab passenger door equipped with a Braun Model L917FIB hydraulic platform handicap lift. Power is provided by a diesel-fueled, Ford Motor Co. model 6.0 L Power Stroke engine coupled to a Ford Motor Co. model 4R100 transmission.

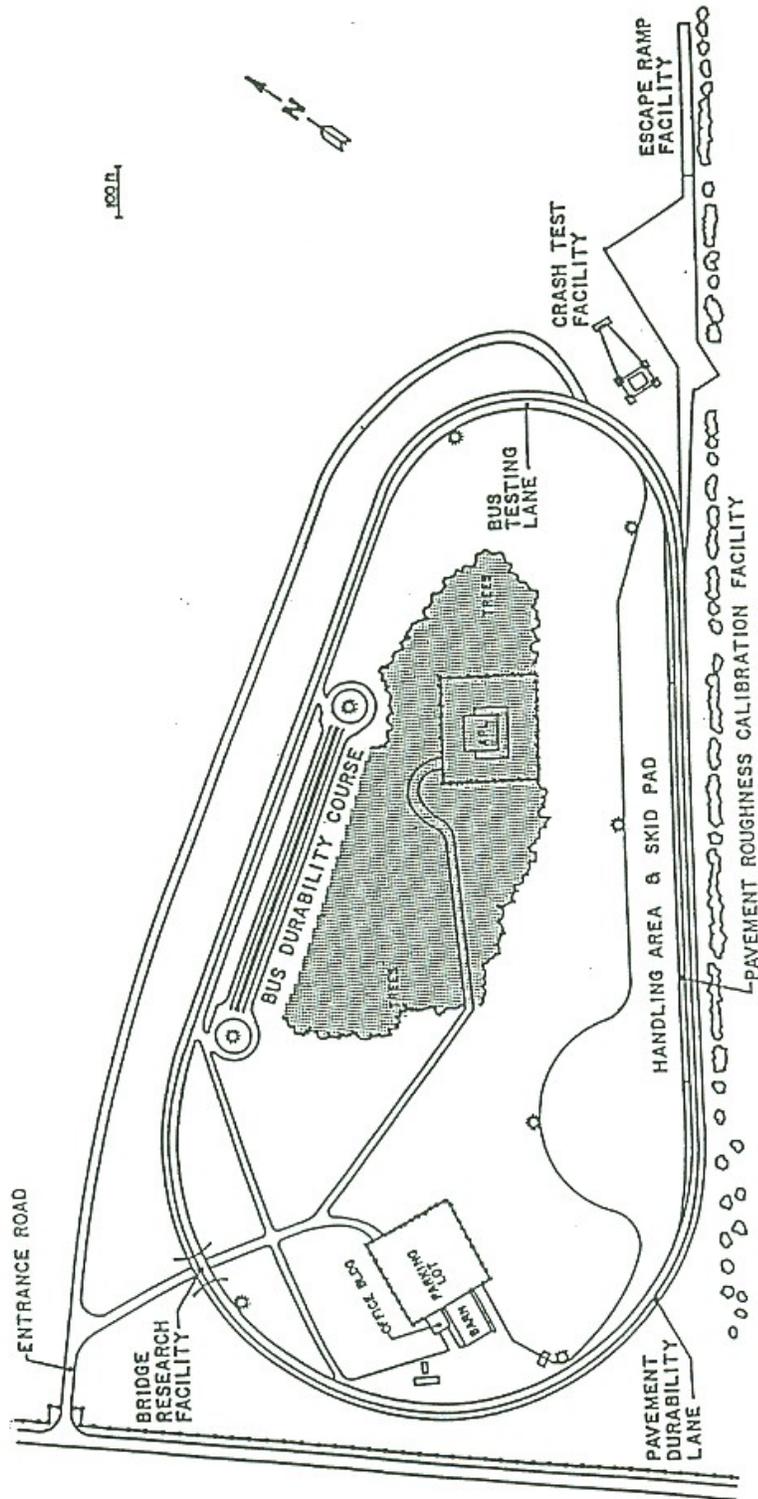
“PLAN VIEW OF PENN STATE BUS TESTING AND RESEARCH FACILITY”

BUS TESTING AND RESEARCH TEST TRACK
UNIVERSITY PARK, PA

The following mileage summary presents the accumulation of miles during the Structural Durability Test. The driving schedule is included, showing the operating duty cycle. A detailed plan view of the Test Track Facility and Durability Test Track are attached for reference. Also, a durability element profile detail shows all the measurements of the different conditions.
