**PARTIAL
STURAA TEST
7 YEAR
200,000 MILE BUS
from
ROUSH CLEANTECH, LLC.,
A MICHIGAN LIMITED LIABILITY COMPANY
MODEL 2011 ELDORADO
JUNE 2012
PTI-BT-R1207**

**The Thomas D. Larson
Pennsylvania Transportation Institute
Vehicle Systems and Safety Program**

Roush CleanTech, LLC., a Michigan Limited Liability Company submitted a model 2011, propane-powered 15 seat/25-foot bus, for a partial STURAA test in the 7 yr/200,000 mile category. The Federal Transit Administration determined that the following tests would be performed: 4. Performance/Performance and Brake Testing, 5.1 Structural Shakedown, 5.2 Structural Distortion Test, 6. Fuel economy, 7. Noise Tests and 8. Emissions Testing. Testing started on April 20, 2012 and was completed on June 8, 2012. The Check-In section of the report provides a description of the bus and specifies its major components.

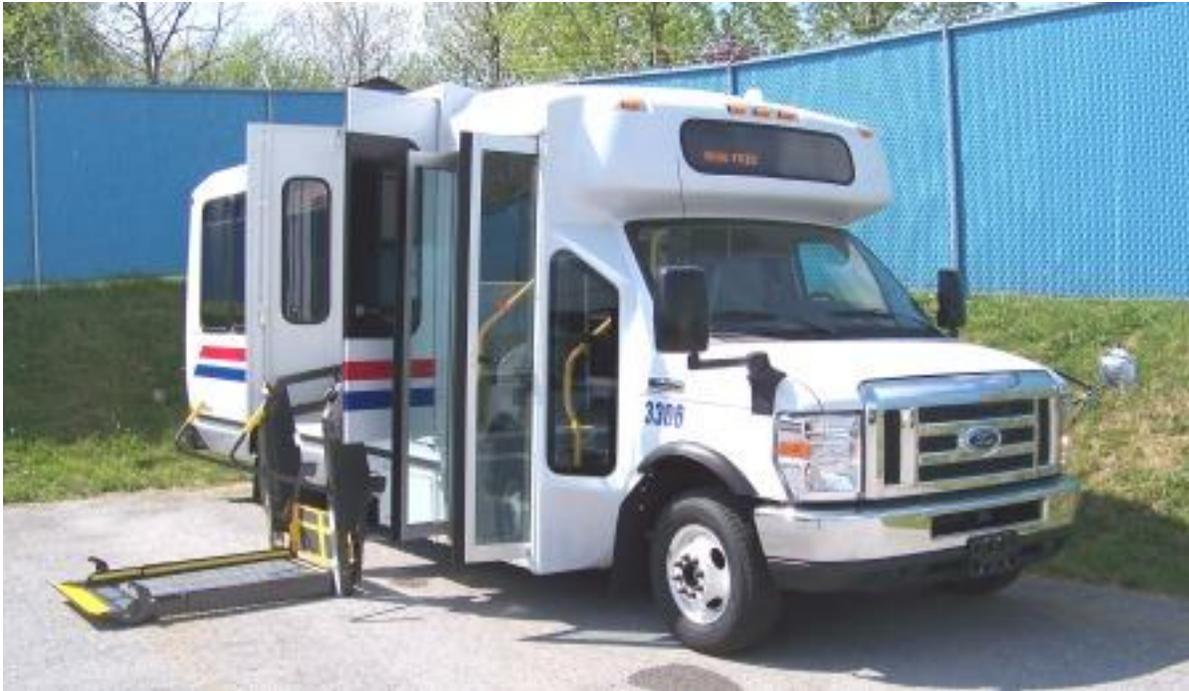
ROUSH CLEANTECH, LLC., MODEL 2011 ELDORADO EQUIPPED WITH A BRAUN MODEL NCL919FIB-2 PLATFORM LIFT

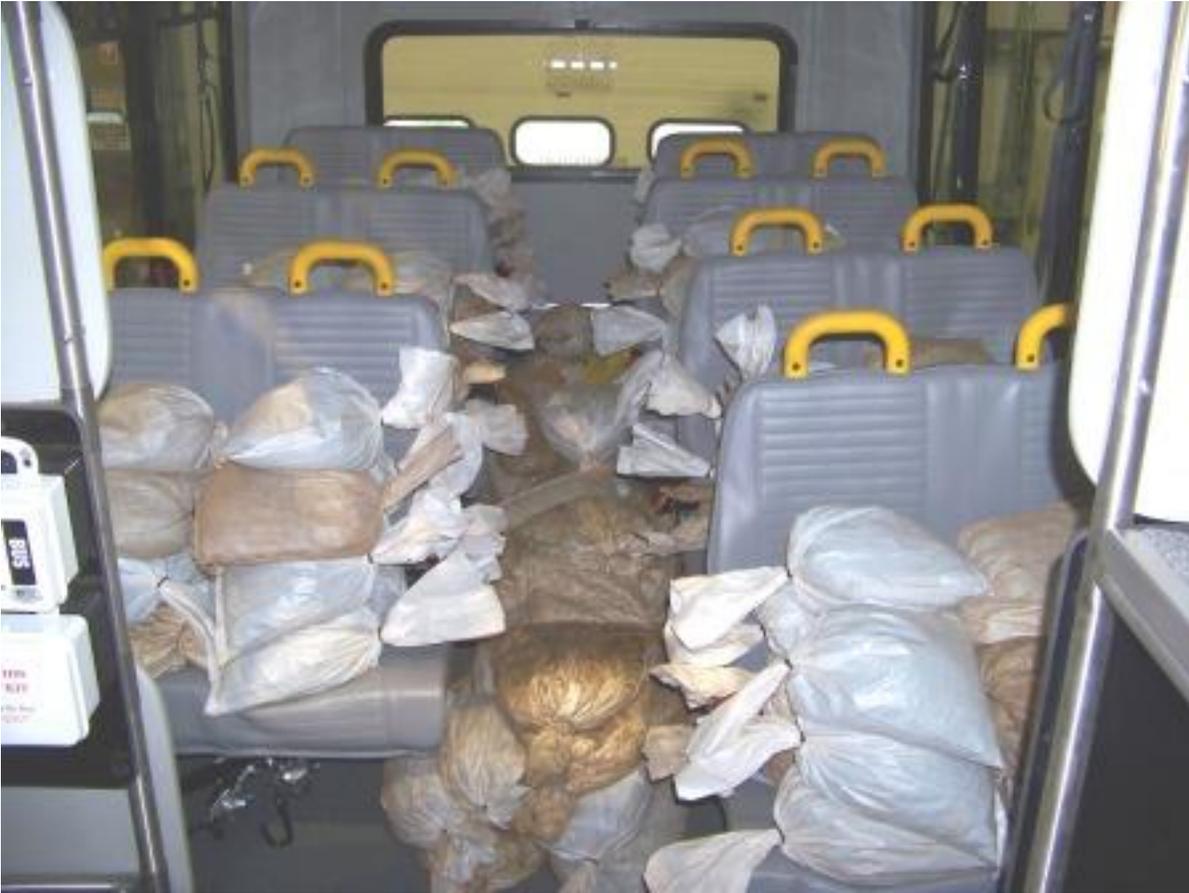
**TEST BUS LOADED TO 2.5 TIMES GVL
(8,250 LBS)**

The Shakedown Test produced a maximum final loaded deflection of 0.213 inches with a permanent set ranging between -0.004 to 0.003 inches under a distributed static load of 8,250 lbs. The Distortion Test was completed with all subsystems, doors and escape mechanisms operating properly. Water leakage was observed during the propane fill nozzle and at the bottom of the 3rd window, left side.

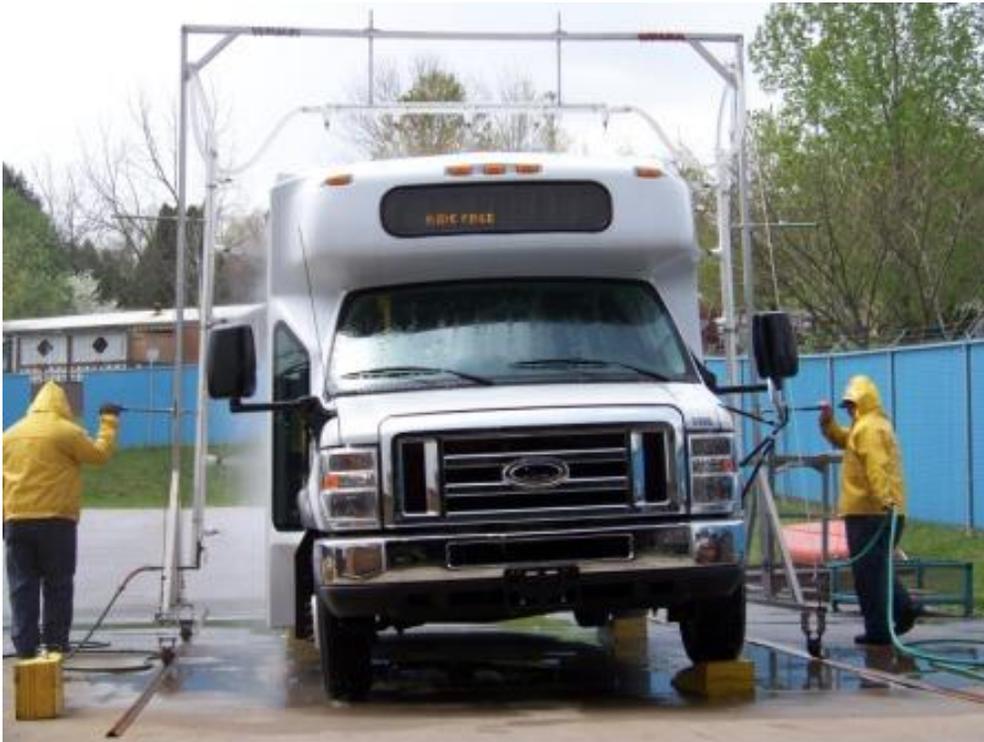
RIGHT FRONT WHEEL SIX INCHES LOWER

All doors, windows, escape mechanisms, engine, steering and handicapped devices operated normally throughout the test. The undercarriage and body indicated no deficiencies. Water leakage was observed during the propane fill nozzle and at the bottom of the 3rd window, left side. The results of this test are indicated on the following data forms.

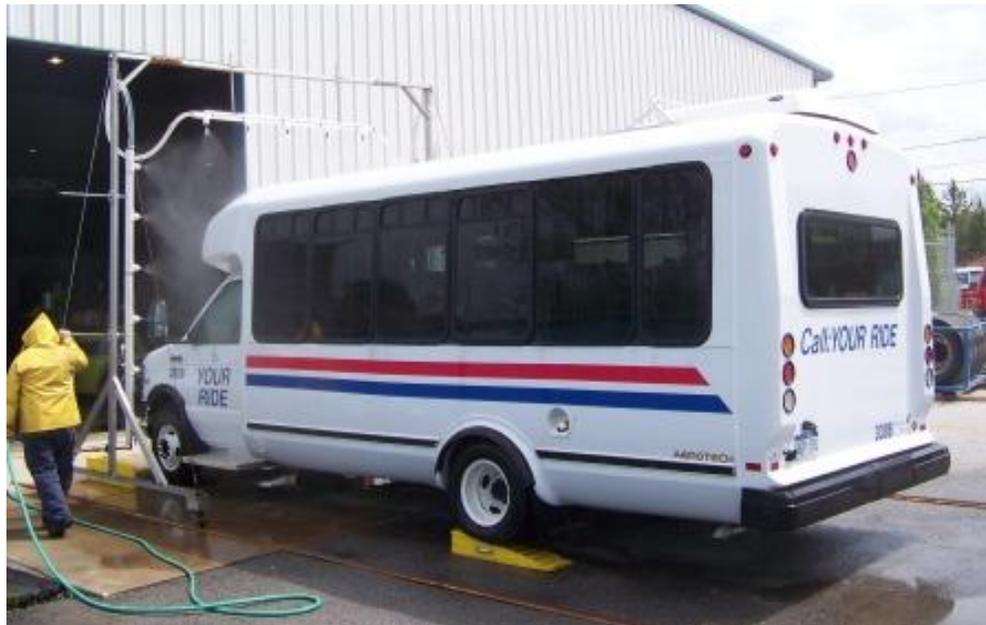
LEFT REAR WHEEL SIX INCHES HIGHER

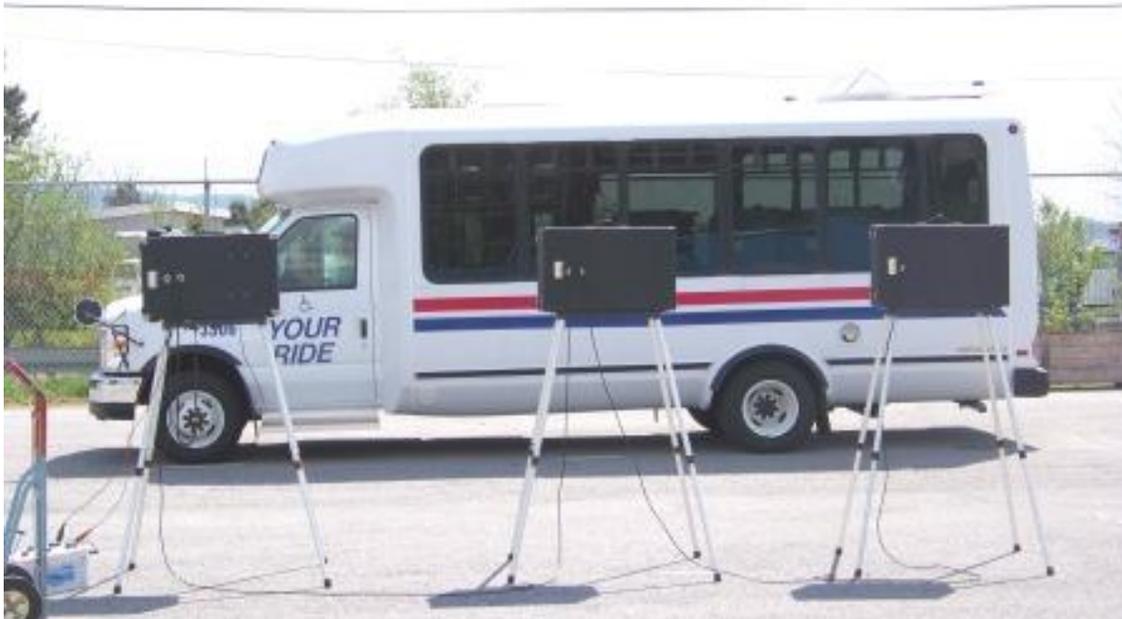
**TEST BUS SET-UP FOR 80 dB(A)
INTERIOR NOISE TEST**

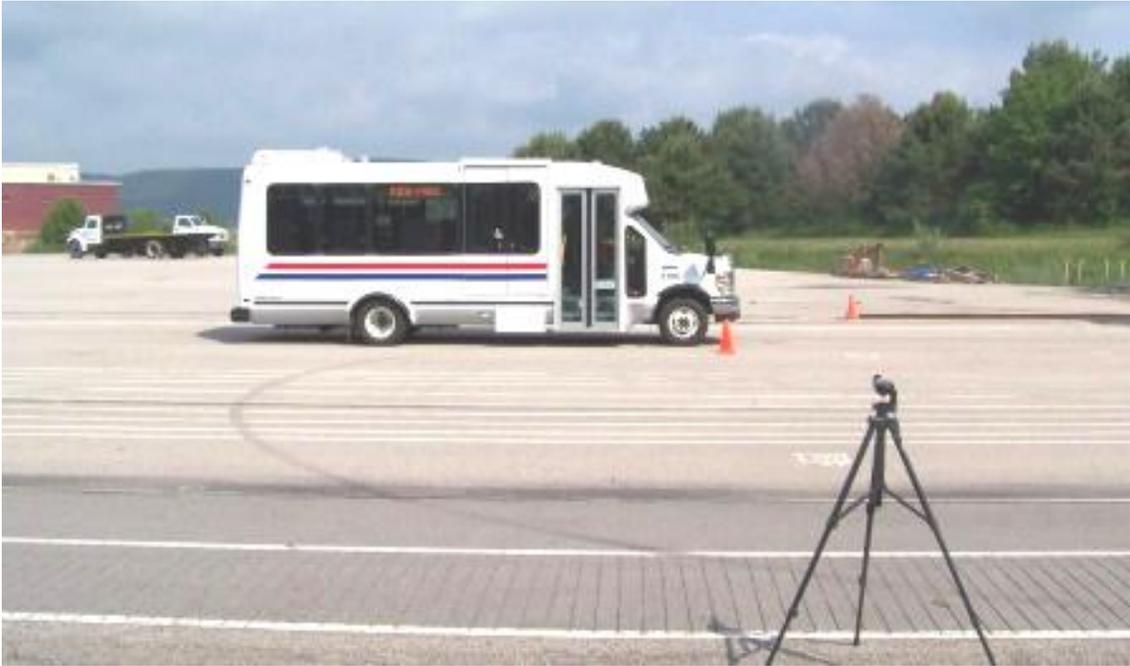
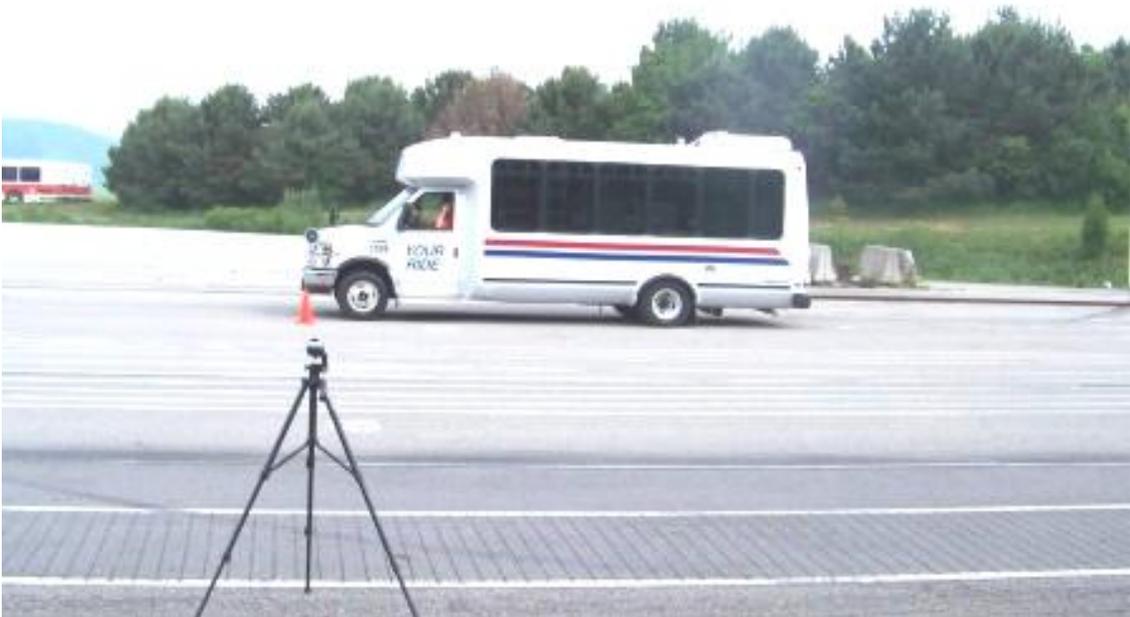
TEST BUS UNDERGOING EXTERIOR NOISE TESTING

The Exterior Noise Test determines the noise level generated by the vehicle under different driving conditions and at stationary low and high idle, with and without air conditioning and accessories operating. The test site is a large, level, bituminous paved area with no reflecting surfaces nearby.

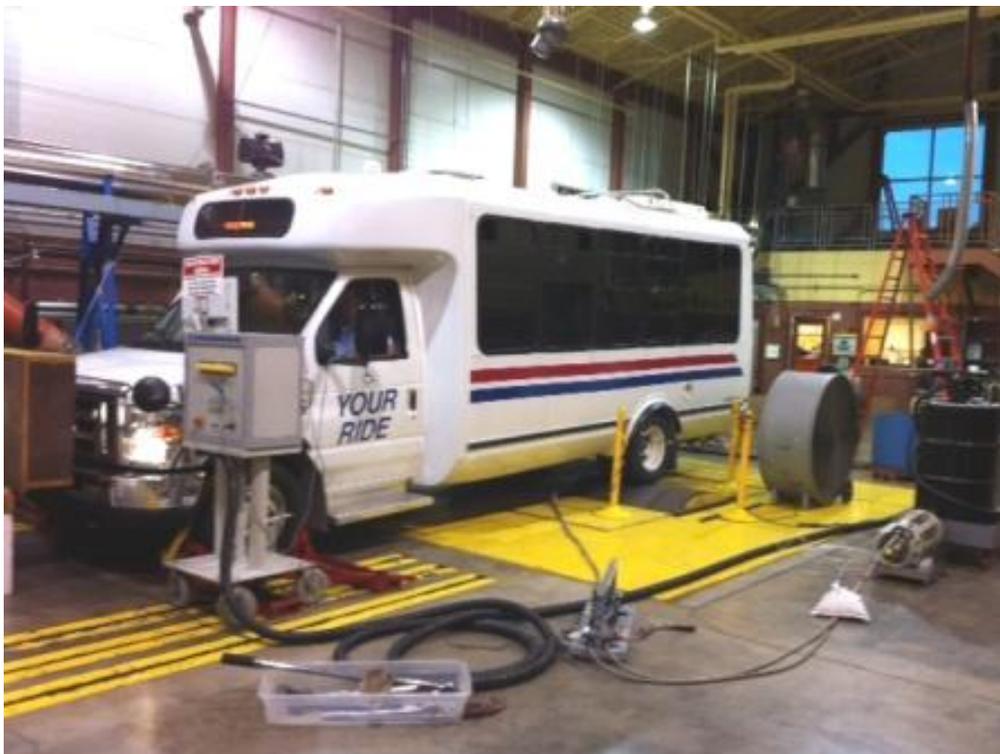
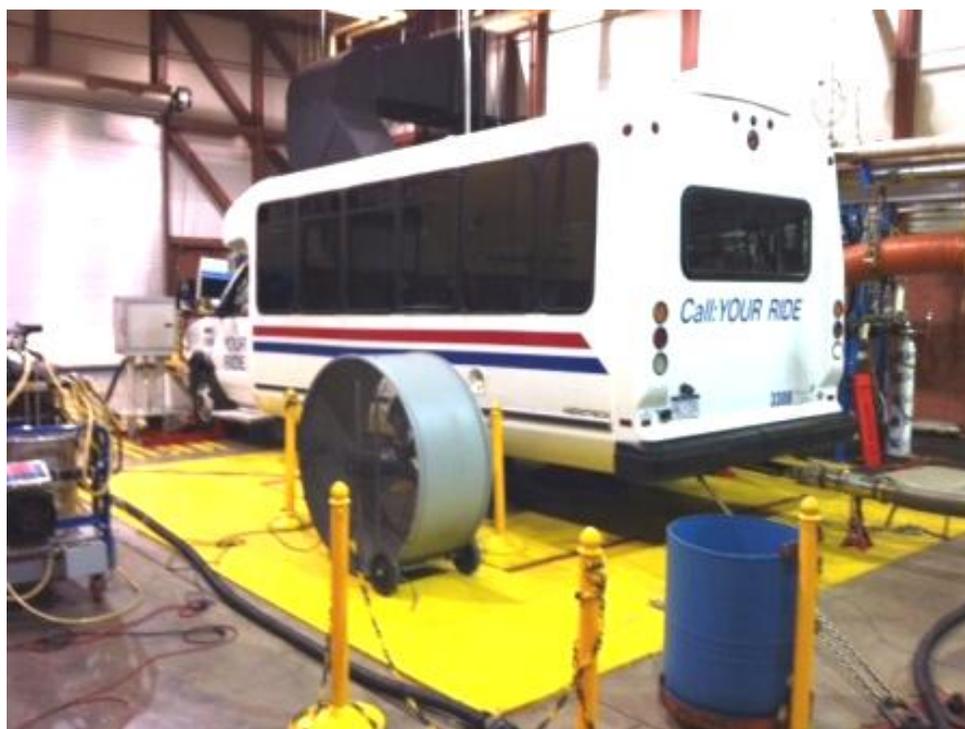
**ROUSH MODEL 2011 ELDORADO
UNDERGOING EMISSIONS TESTING**
