**Addendum Number: Three (3)**

**CAP Project Number: 15151DB Solicitation**

**Project Name: Oklahoma Capitol Restoration - Interior Rehabilitation**

Item #1: "Attachment 1 - Owner's Project Team Investigations: The Existing Structure Evaluation Report" to RFP. Report from Wallace Engineering dated January 21, 2015; 23 pages.

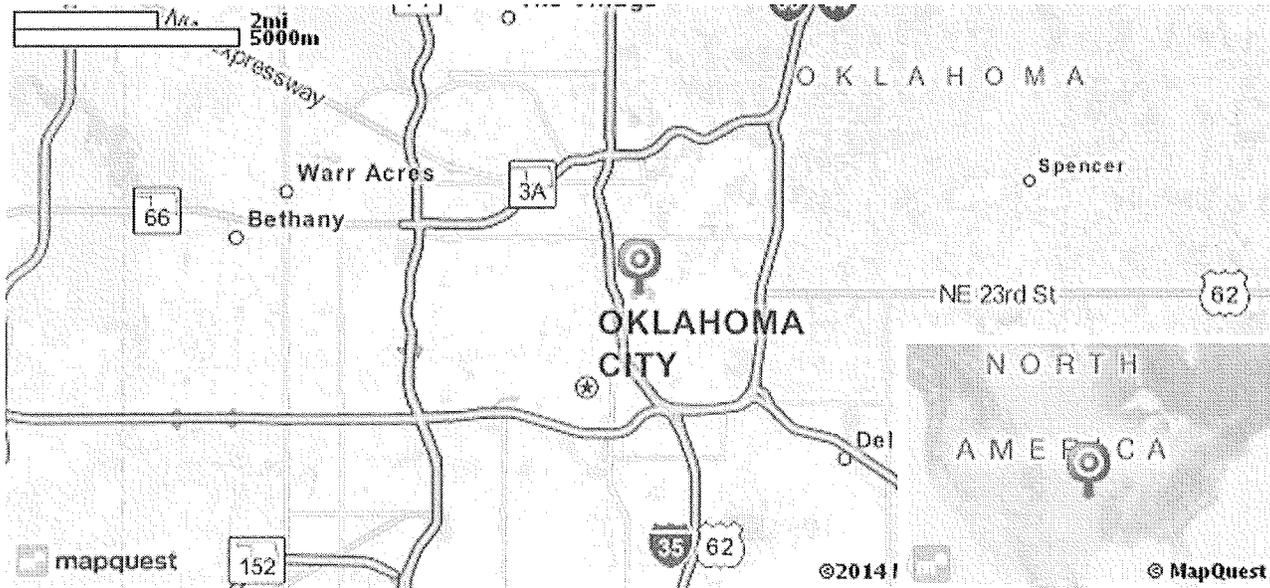
**Building Code Reference Document** ASCE 41-13 Retrofit Standard, BSE-1E  
 (which utilizes USGS hazard data available in 2008)

**Site Coordinates** 35.4922°N, 97.5034°W

**Site Soil Classification** Site Class C - "Very Dense Soil and Soft Rock"
